AirMaintenance

Electrical Power Relays Need Maintenance

BY JIM LESLIE, VP COMPONENT OVERHAUL, NAASCO NORTHEAST CORP.

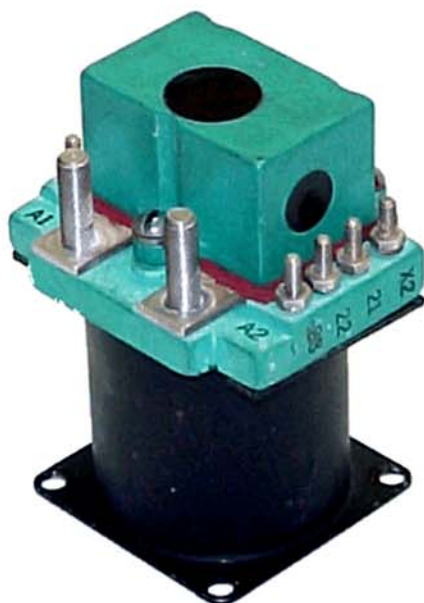
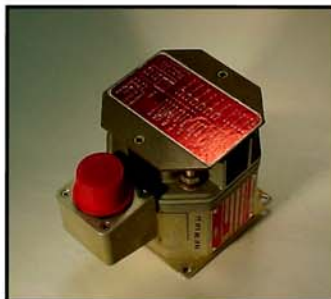
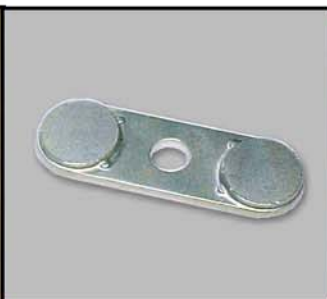
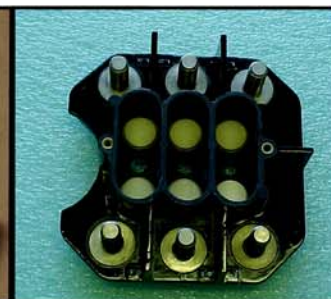
far left: A-1077-Series fitted to Light Turbine Aircraft. below, left to right: Boeing 737 power relay, a movable contact from Boeing 727 relay, contact set from Hartman B-102F power relay, Terminal board with embedded stationary contacts.

Most relays are electromechanically operated using a plunger type solenoid. When a "close" signal is applied to the relay close circuit, the plunger is pulled down with enough force to overcome the spring tension that holds the contacts in the open position and is held in the closed position by a permanent magnet

latching circuit. The plunger movement pulls the moveable contacts to the stationary contacts closing the circuit and actuating any auxiliary switches which are incorporated into the unit. Relays can have as few as one auxiliary switch to as many as 10 or more. These low current switches can operate anything from the latching circuit to cockpit annunciator lights. The movable contacts assemblies in the relay are usually made up of a conductor, composed of solid copper or bronze, fitted with a silver alloy button on one side that makes contact with a stationary bus bar. This bus bar usually consists of a contact button surface at one end and a threaded stud on the other end for fastening securely to the power or load source.

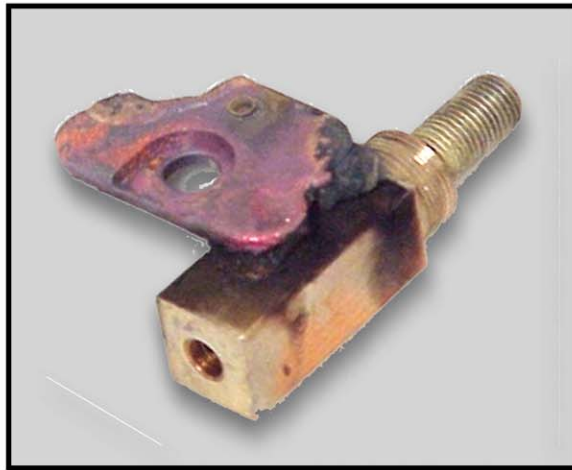
Contacts fused together

Relay failure can cause many problems. For example, if a 28 volt turbine engine starter generator relay fails in the open position, the starter will not turn the engine. If it fails in the closed position (contacts fused together due to melt down), the starter will turn as soon as the battery switch is turned on.

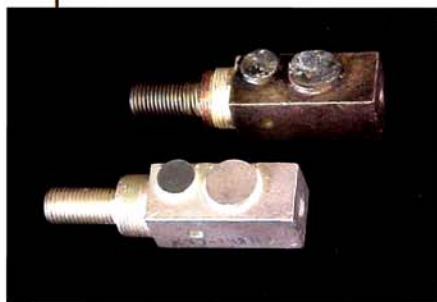
Contact Check Diagram
Figure 401

- A. Contact as shipped but after test has been completed.
B. After a period in service, acceptable.
C. Point of replacement, 50% of the area, 70% of the diameter pitted.
D. Unacceptable, destroyed.

above: Excerpt from Hamilton Sundstrand Manual 24-20-87 PN 9008D09 used on DC9/MD80.

- D. Check the contacts (14, IPL Figure 1) and the contacts of terminal board (36). Figure 401 illustrates the desired characteristics and the point of replacement. For slightly pitted contacts, a fine file may be used to refinish the contacts. The contour of the contacts shall not be changed and the contact height shall be approximately the same. Wear will be uniform on both stationary and moving contacts. Therefore, the terminal board and moving contacts should always be replaced as a set.
