Unparalleled Repairs for ECE/Teleflex Landing Light Motors

ECE/TELEFLEX LANDING LIGHT FITTED TO AIRBUS FAMILY

REPAIR SUMMARY

Repairs for ECE/Teleflex Landing Light Motors

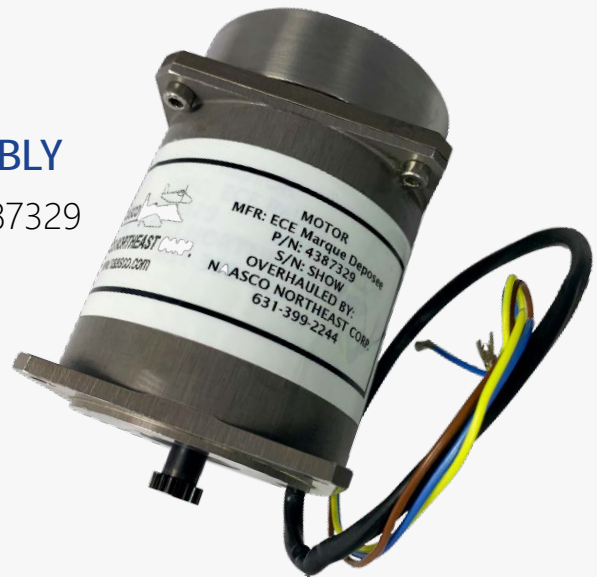
PN: 4387329

MOTOR ASSEMBLY

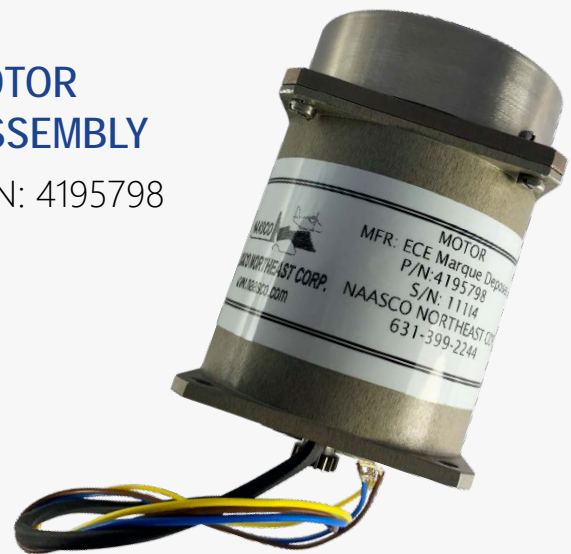
PN: 4195798

MOTOR ASSEMBLY
