## Repairs for Honeywell Landing Light Assembly

# REPAIR SUMMARY

## FAA-DER APPROVED REPAIR

Date: June 23, 2011

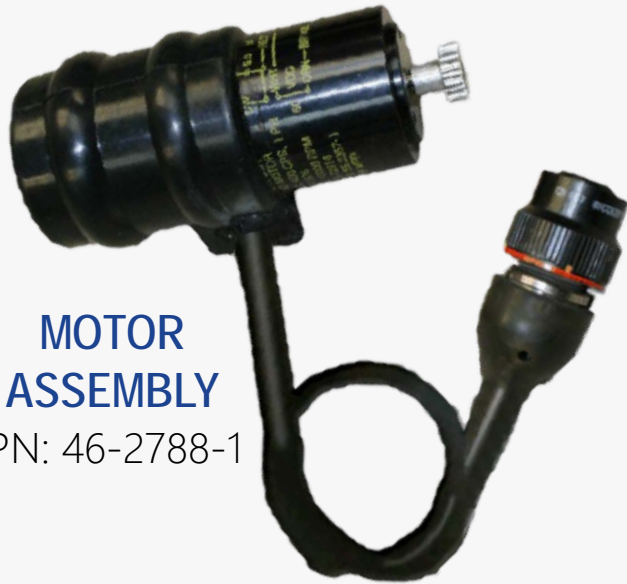
**MOTOR  
ASSEMBLY**  
PN: 46-2788-1

Motor Assembly  
46-2788-1  
converted to  
46-2788-3  
at

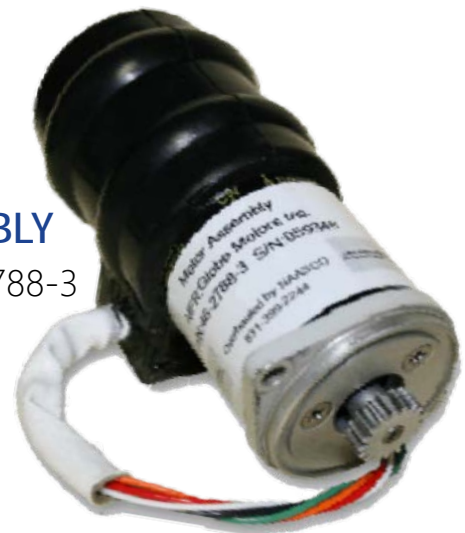
PN: 46-2788-3

Motor Assembly PN 46-2788-1 converted to 46-2788-3 at **NO EXTRA CHARGE**
