## Unparalleled Repairs for ECE/Teleflex Landing Light Motors

# REPAIR SUMMARY

## FAA-DER APPROVED REPAIR

### Repairs for ECE/Teleflex Landing Light Motors

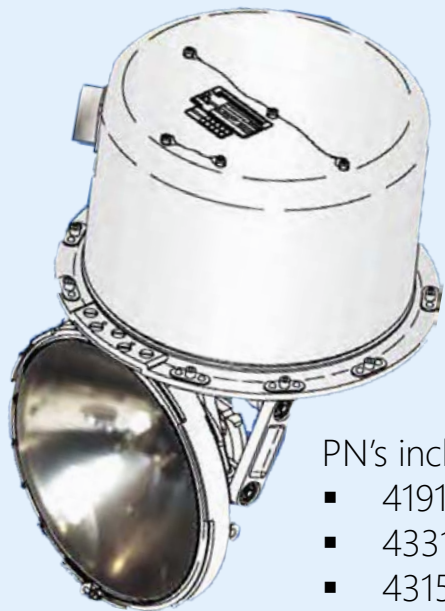
### ECE/TELEFLEX LANDING LIGHT FITTED TO AIRBUS FAMILY

- 4191695
- 4331772
- 4315542

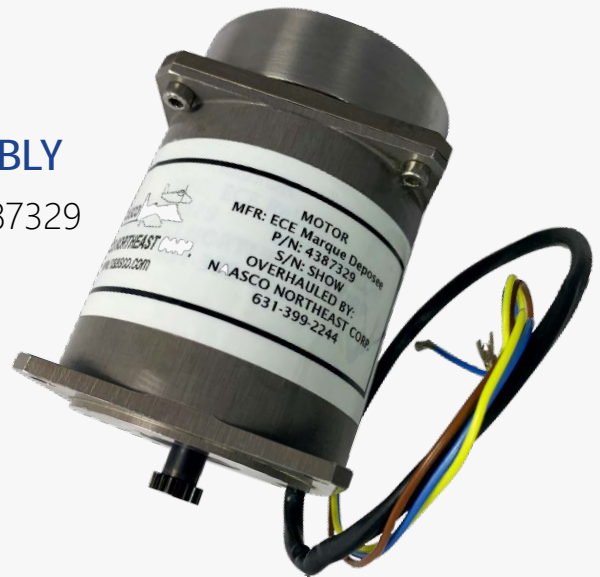
PN: 4387329

### MOTOR ASSEMBLY

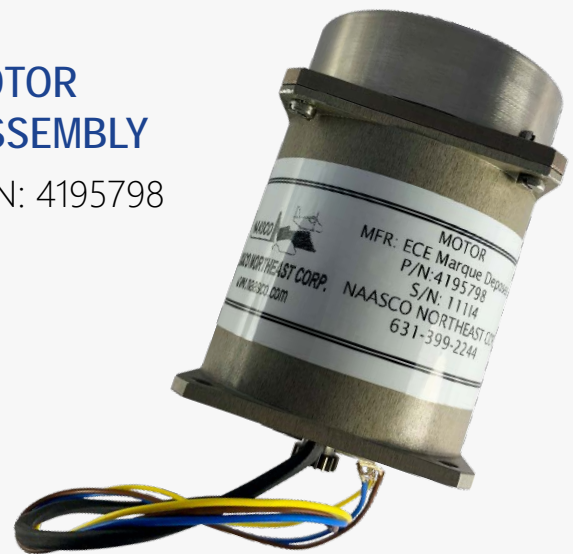
PN: 4195798

### MOTOR ASSEMBLY
